DAMPNESS PATTERN IN HALLS OF RESIDENCE IN SELECTED EDUCATIONAL INSTITUTIONS IN LAGOS, NIGERIA

Zakariyyah, K. I.¹, Faremi, O. J.¹, Soyingbe, A. A.¹, Ajayi, O. O.¹, John, I. B.², Aregbesola, G. T.¹, Aderogba, M. A.¹, Tijani, M. S.¹, Simeon, R. D.¹ and Bolajoko, A. T.¹

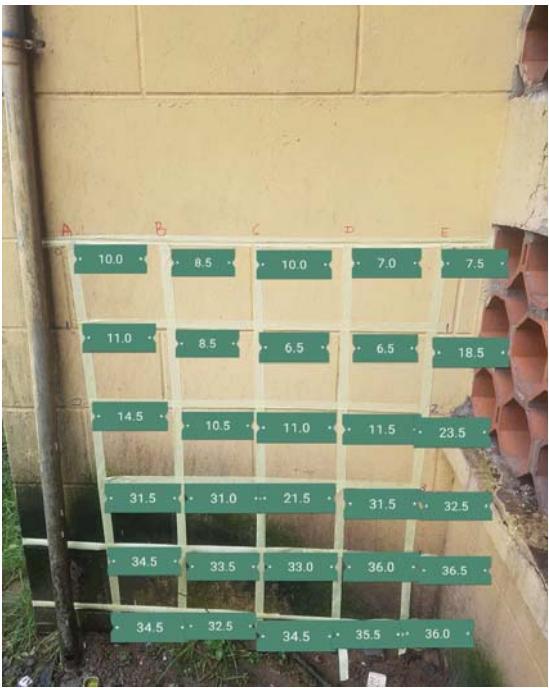
Figure 2: Moisture Meter Readings

The external wall under observation was located on the North-North-West of hall of residence No.1. Hall No. 1 has 3 suspended floors with H-shaped interlink walkway at the first floor, and was constructed in 1974 with cast-in-situ technology on pile foundation. There is a pool of water with some debris at the foot of the wall. The pool of water originated from a damaged rain water-good from the roof. This has resulted into the wall showing dark brown patches, greenish colour, considerable discolouration at the lower level, flaking of mortar and peeling of paint. The pool of water at the foot of the wall has some greenish colour, indicating that 'part of the coloured water' has risen up. The relative humidity readings that ranged from 8.5% to 36.0%, reduced from the foot of the wall upwards, indicating that the dampness was in a progression. The end of the dark brown patches terminated just before the top of the 3rd layer grid (2E-F and 3E-F). The relative humidity at this point was 24%. This height was measured as 560mm which indicated the height of the rising damp. (Please see Appendixes IV to VI and Figure 2). The moisture meter showed grids 2D-E as 'dry', 2E-F as 'wet' 2-3A-F as 'wet' and 3-5A-E as 'very wet'.

The moisture meter readings on one of the walls of the halls with severe perceived moisture problem revealed a rising damp at a height slightly lower than 600mm. The height of the brown-dark patches and the greenish colour revealed that the wall is porous and permeable thereby making it possible for water to travel up through capillary action, with probable salts deposit. The inner side of the wall in discussion houses a large store which could not be accessed. The damage done on the wall is already evident from mere observation, additional test however need to be conducted in order to know the types, the sources and the quantity of salts present and the likely further damage. One might feel that a rising damp of 560mm might not be worrisome, the effect on this wall is however obvious based on the colour at the plinth level and the high concentration of moisture based on the moisture meter readings. The 560mm height could have resulted due to the wall location, which is on the North-North-West of hall No.1, thereby making it difficult to get enough sunlight and air movement that will facilitate evaporation. The minor test carried out on condensation revealed that the condensation is from the wall. This calls for further concerns.

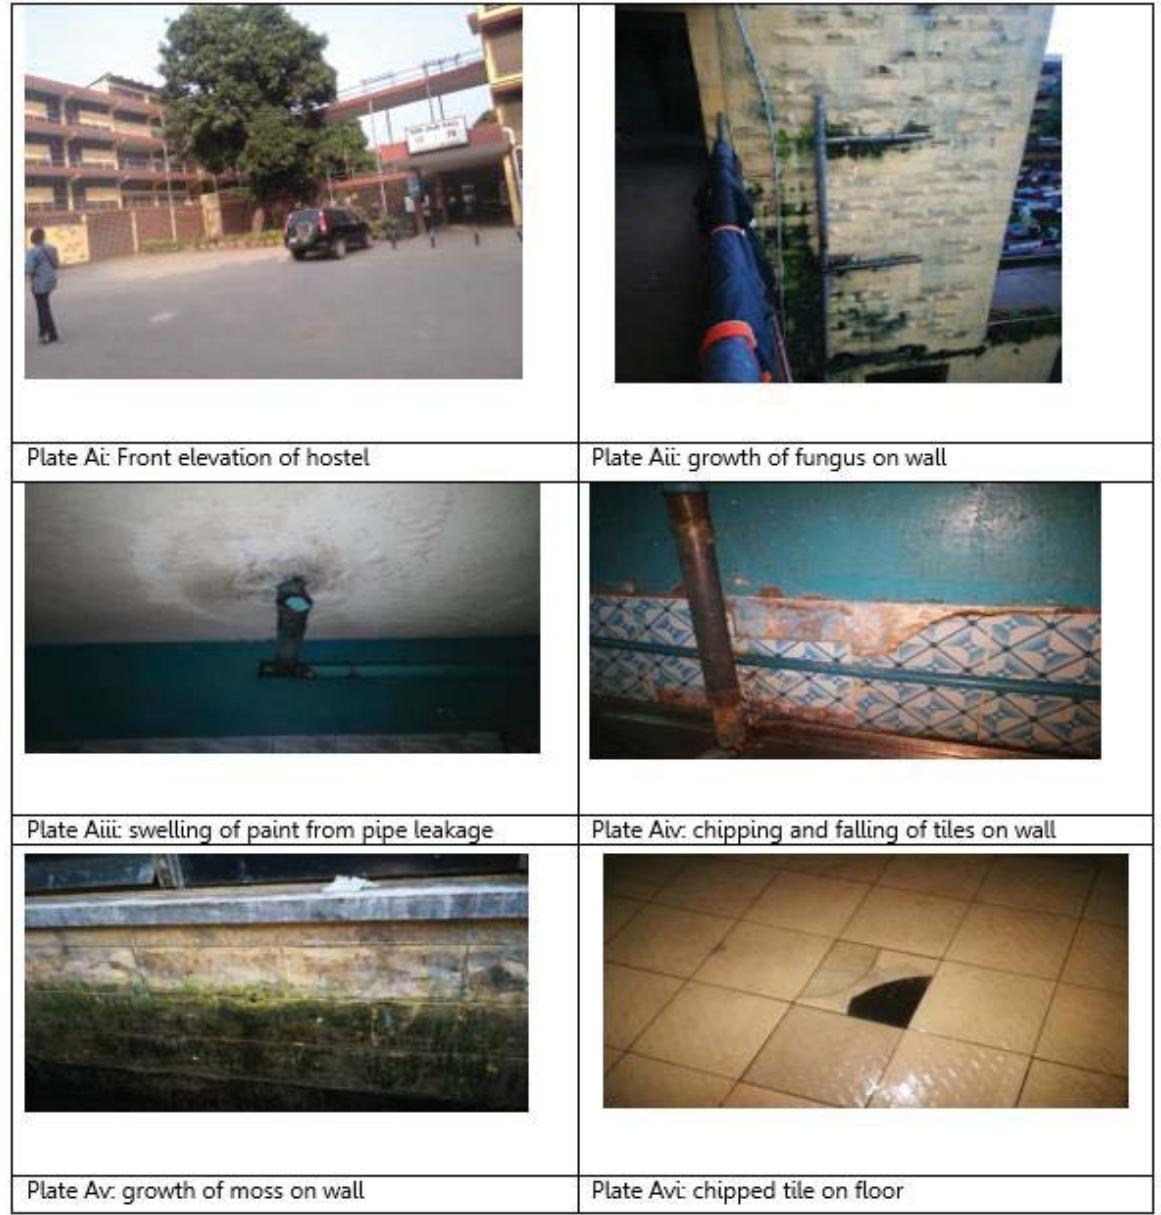
Appendix II : Pictorial representation of dampness observed at hall No. 1

Dampness problem observed at hall of residence No.1.

Observed in this hall of residence are pipe leakages, tile chipping, discolouration, mould and fungal growth, spalling of structural members as shown in plates i-vi...

In the meantime, the halls identified with perceived severe dampness problems should be given adequate attention by the management to forestall further consequences and finally, the rising damp presence was enhanced by the pool of water and the collection of debris, the sources of the pool of water and the debris should be attended to with immediate effect. In other words, inspections should be carried out in the halls and attention given to the necessary repair and maintenance works as at when due.

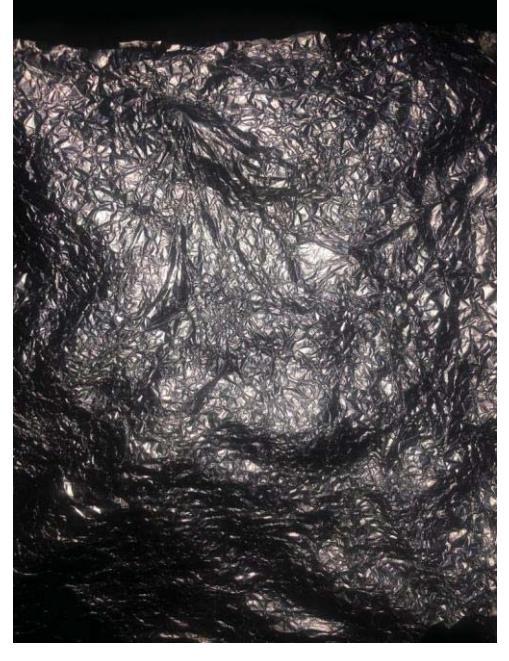
Appendix VII: The condensation test result indicating condensation from the inner side (face of the wall) of the foil paper
